# **JICA's Assistance for Nepal Earthquake Reconstruction ~Basic Infrastructure Support for Resilient Society~**

**Urban and Regional Planning Development Group,  
Infrastructure and Peacebuilding Dept.,  
The Japan International Cooperation Agency (JICA)**

# JICA Effort to Fix Quake-Damaged Schools (1)

# JICA Effort to Fix Quake-Damaged Infrastructure: Kathmandu-Bhaktapur (KB) Road (1)

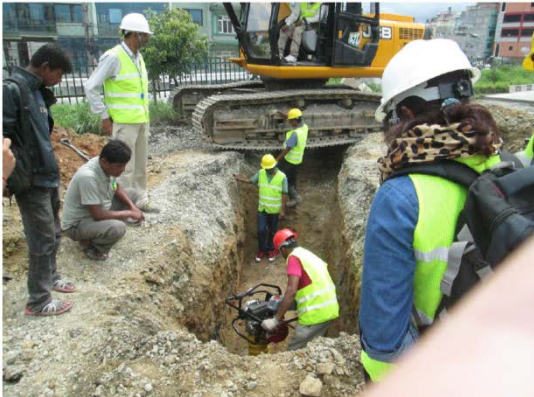
Eastbound Lane Back-filling and Compaction for an Open Crack  
July 20, 2015

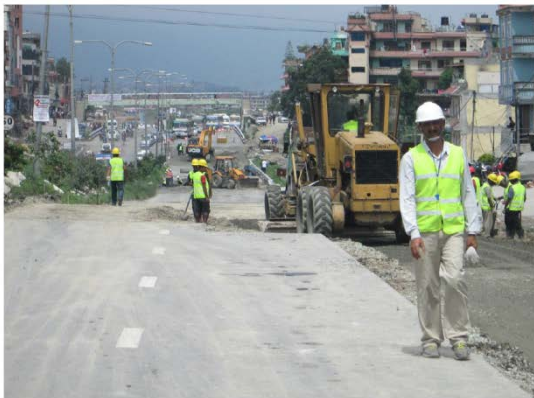
Eastbound Lane Base Coarse Laying July 20, 2015

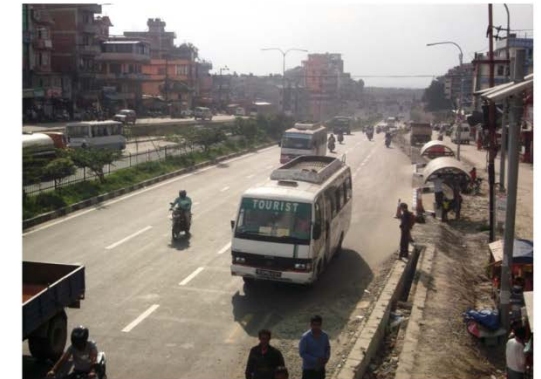
AFTER September 6, 2015

Kathmandu-Bhaktapur Road, Eastbound lane nearby Kaushaltar Bus-stop

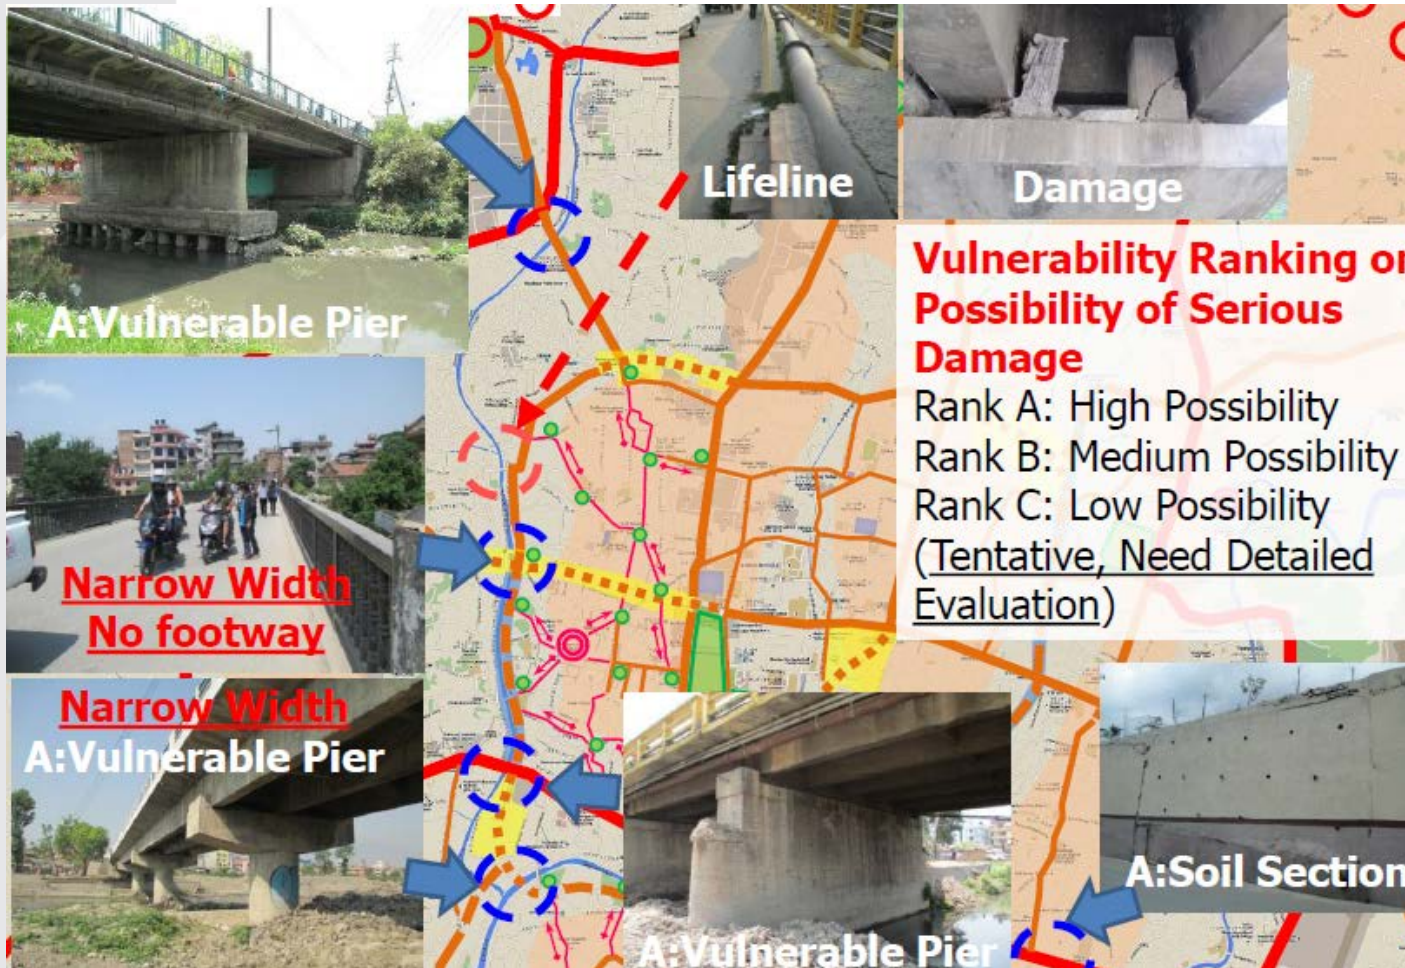
- Weak and Non-ductile Stopper
- Poor Construction Quality (cold joint, thin concrete cover, etc)
- Capacity Bottlenecks (for transport, river flow)

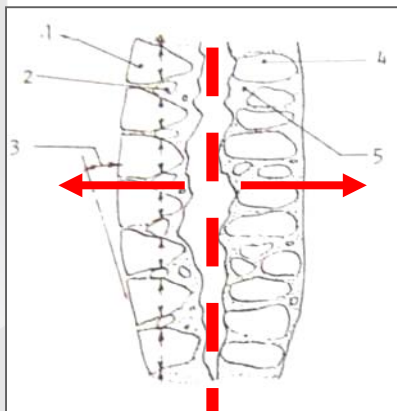
De-lamination

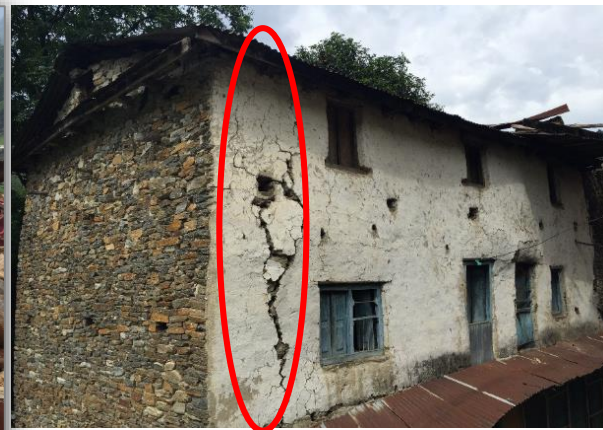
Corner damage

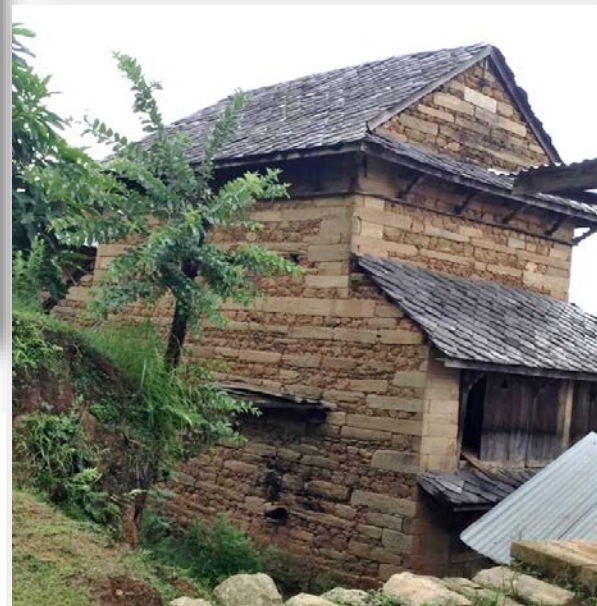
- Mud mortar house with no damage in Gorkha**
- Dressed Stones
  - Interlocking at corner

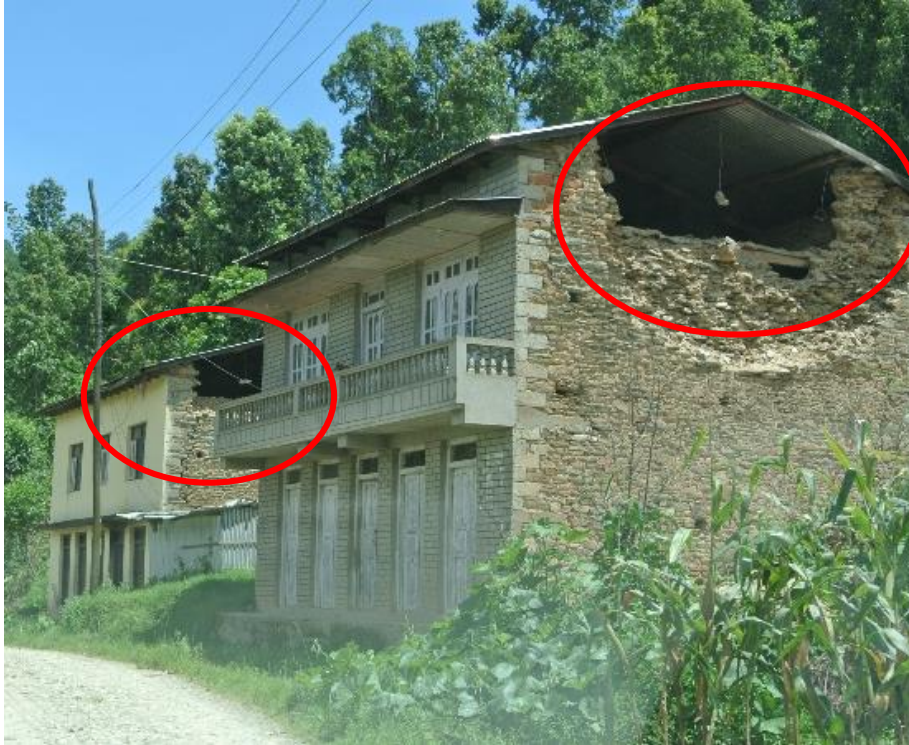
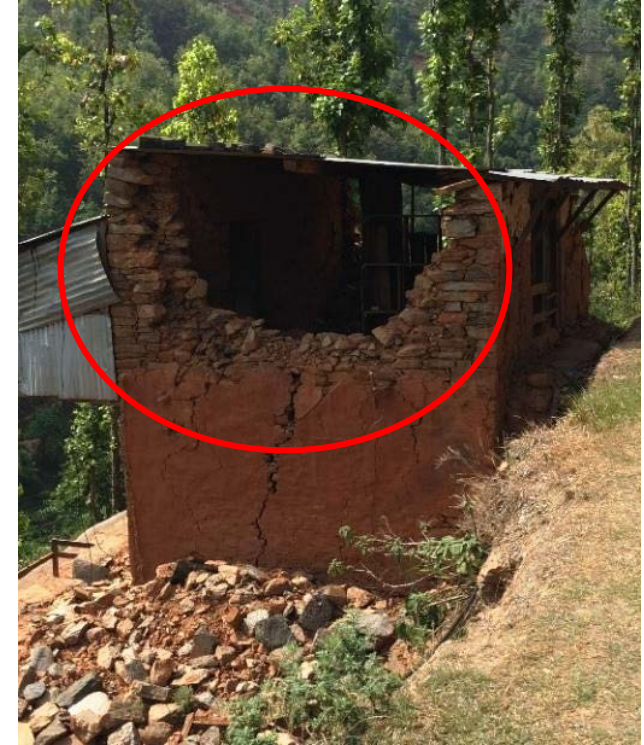
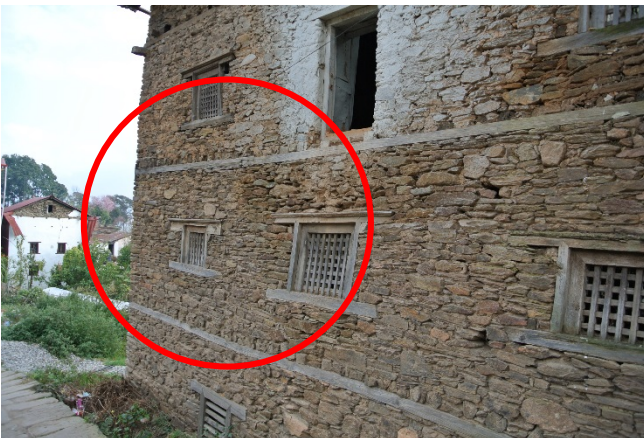
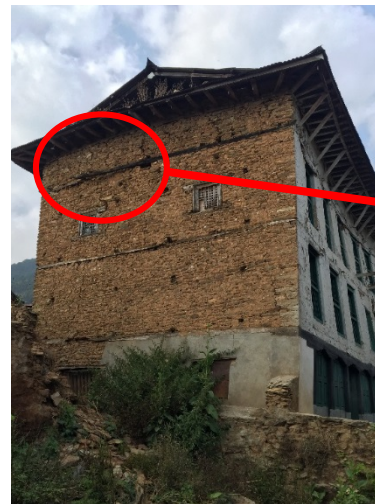
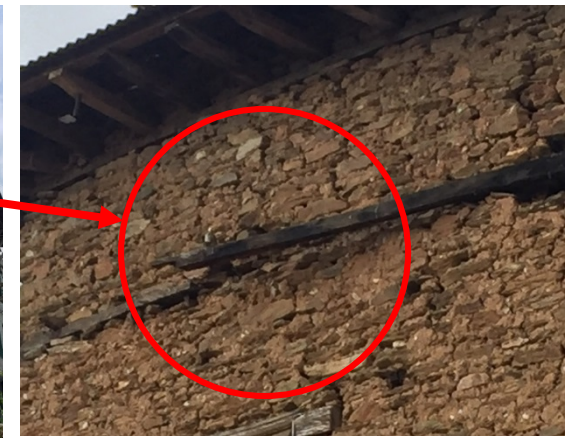
# Typical Damaged House (2): Out-of plane failure

Houses with seismic band has less failure

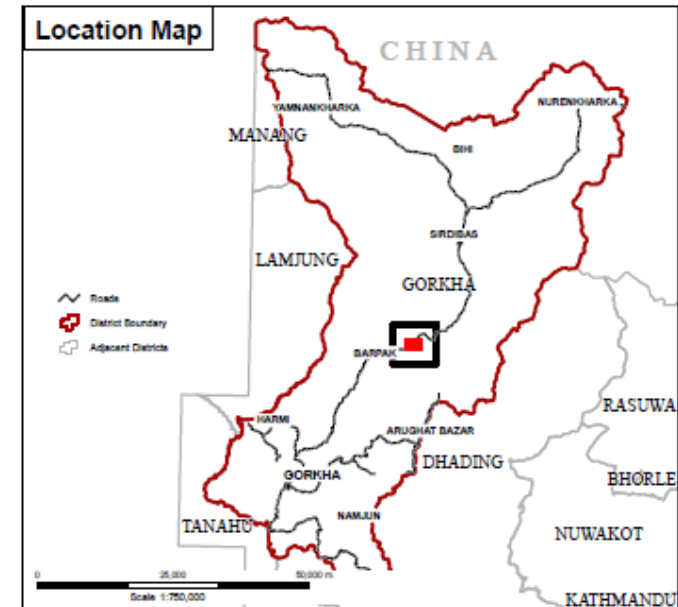
BI19

## LANDSLIDE AREA MAP

**MAP INFORMATION:**  
Map shows information of the District of Gorkha in three types: satellite imagery, topographic map & 3D view.

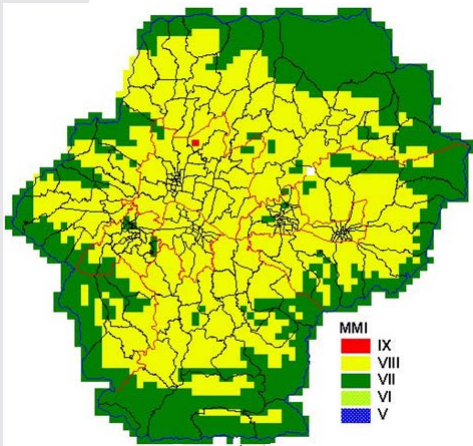
Intensity Map

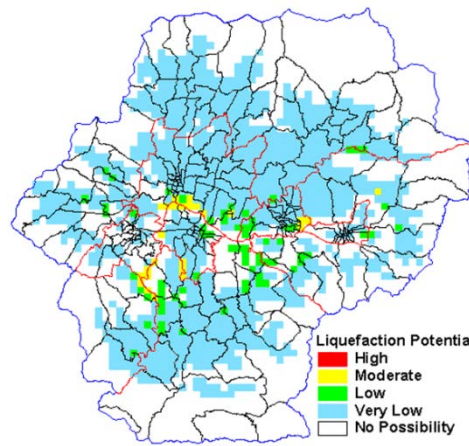
Liquefaction Hazard Map

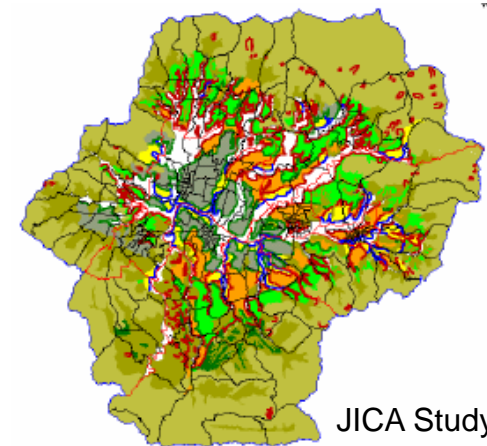
Landslide Hazard Map

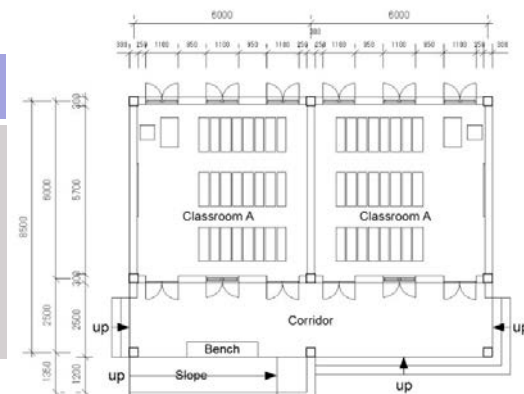
## Single story

Ground Floor Plan 1:200

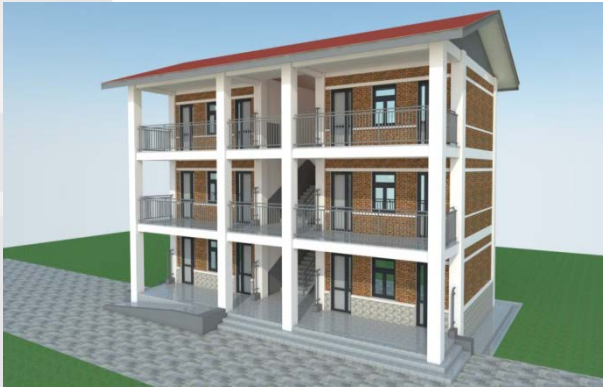
Academic Block,3-6C(S)

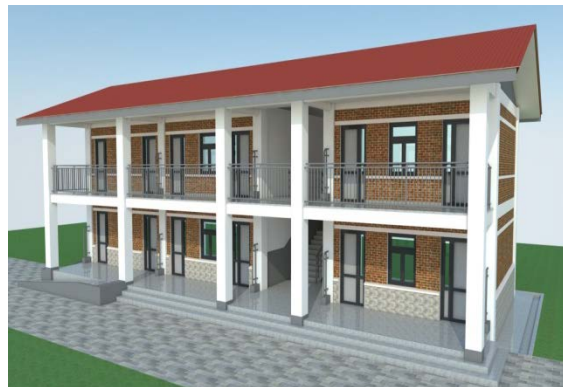
Academic Block,2-6C(S)

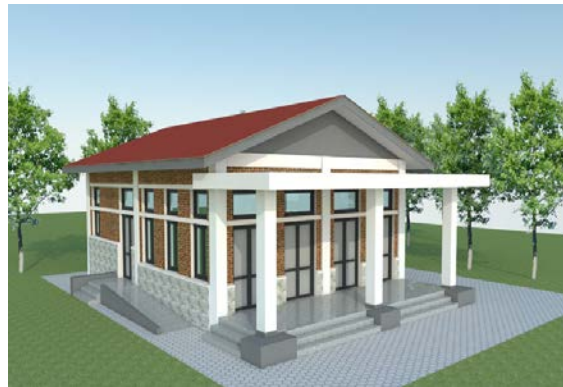
Multipurpose Hall

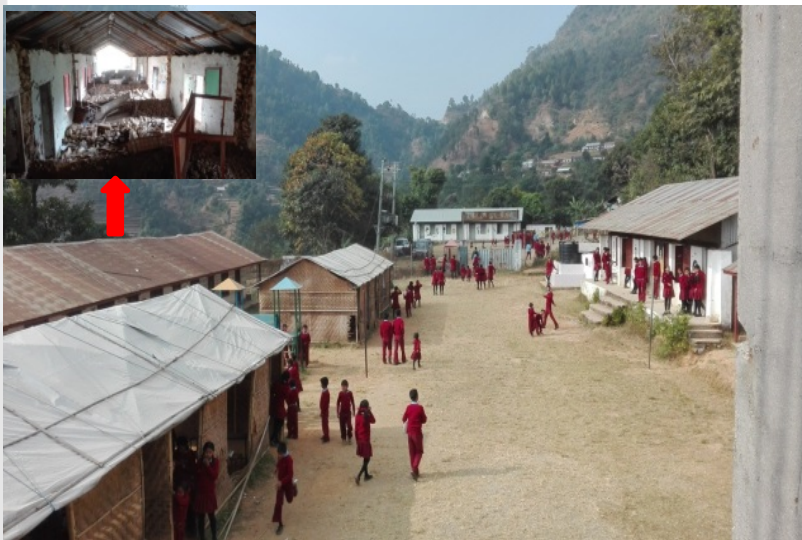
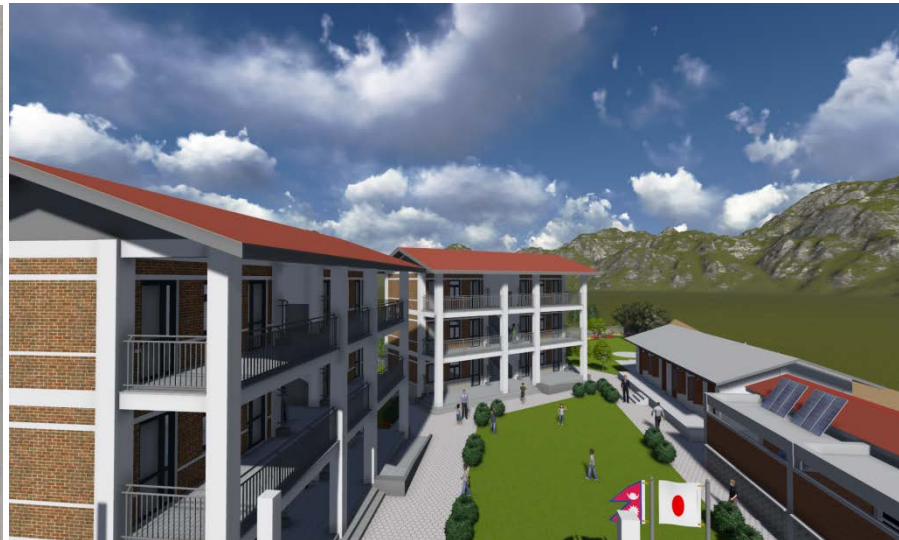
**SHREE KALIDEVI HIGHER SECONDARY SCHOOL: PYUTAR, LALITPUR**  
**EXISTING CONDITION** **PLAN**
